## **SCOPE #2**

**PHOTO SHEET**

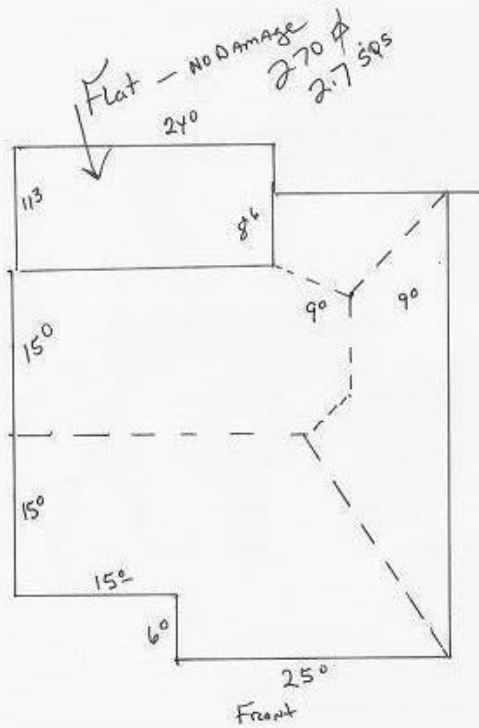
# Roof Diagram

$30 \times 40 = 1200 \text{ } \phi$   
 $6 \times 25 = 150 \text{ } \phi$   
 $8.5 \times 18 = 153 \text{ } \phi$   
 $\frac{1503.00 \text{ } \phi}{225}$   
 $17.2800$

Concrete  
Flat Tiles

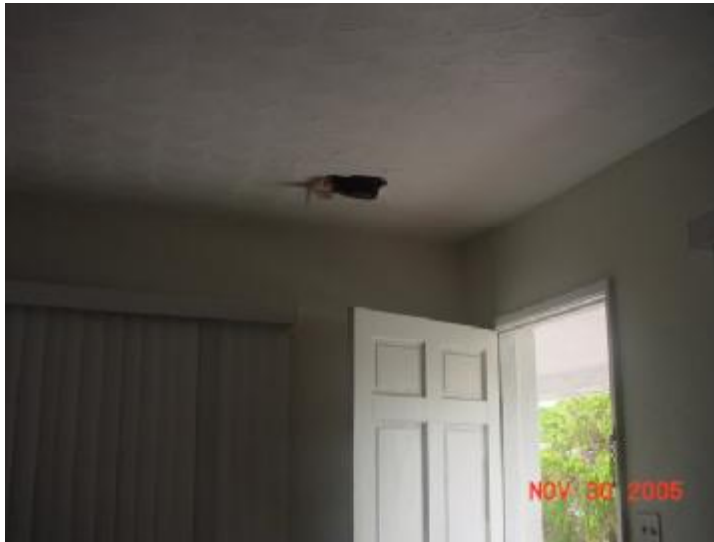
3 LIVING ROOM 11/30/2005  
WATER DAMAGED TEXTURE CEILING

#### REPAIR CEILING

Drywall w/ Heavy (Hand) Texture – Remove & Replace 32SF  
Insulation (BT10) – Remove & Replace 32SF  
Paint Ceiling

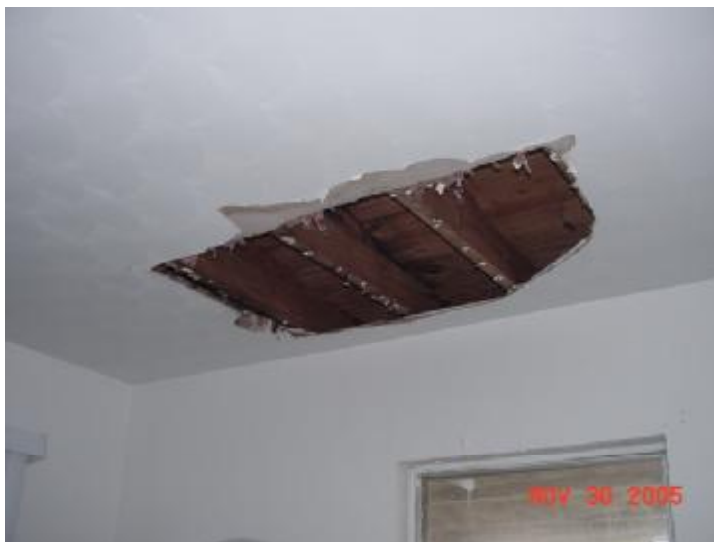
4 BEDROOM CEILING 11/30/2005  
water damaged drywall ceiling with heavy texture

#### REPAIR CEILING

Drywall w/ Heavy (Hand) Texture – Remove & Replace 64SF  
Insulation (BT10) – Remove & Replace 64SF  
Paint Ceiling

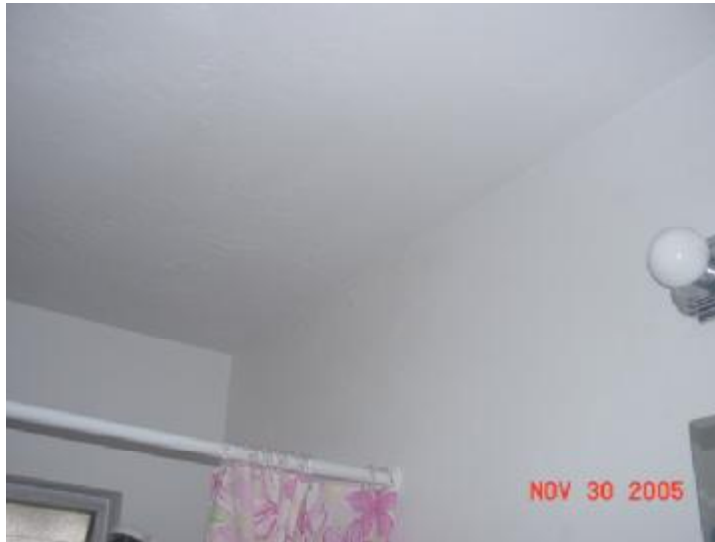
5      **BATHROOM  
CEILING**      11/30/2005  
**LIGHT WATER STAINS**

Paint Ceiling/ Walls (light water stains)

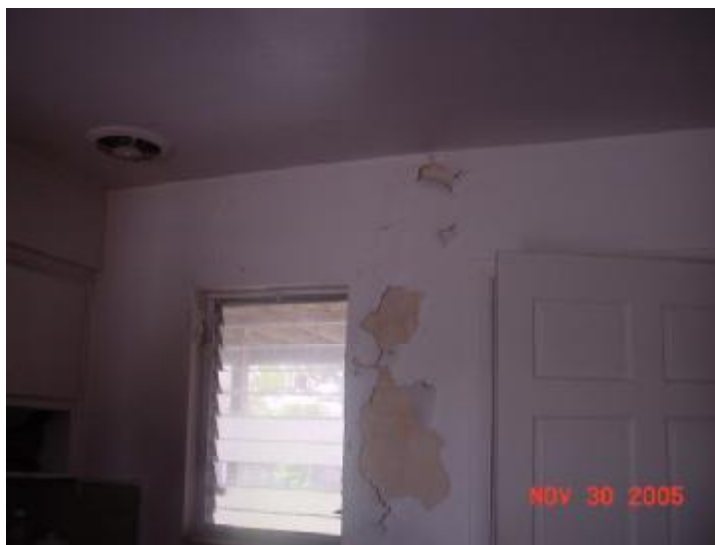
6      **KITCHEN**      11/30/2005  
**WATER DAMAGED WALL**

#### REPAIR WALL

Drywall (1/2") ready for paint – Remove & Replace 64SF  
Insulation (BT6) – Remove & Replace 64SF  
Paint Ceiling and Walls

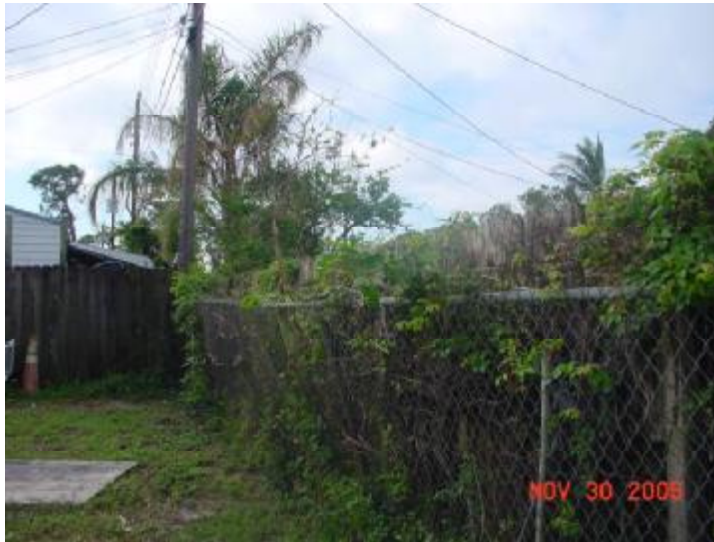
8      **FENCE  
DAMAGE**

50 FT chainlink fence bent and leaning due to wind force

FENCE: Remove & Replace 50 LF OF 6' HIGH CHAINLINK  
R&R 32" x 6' 8" EXTERIOR DOOR & PAINT

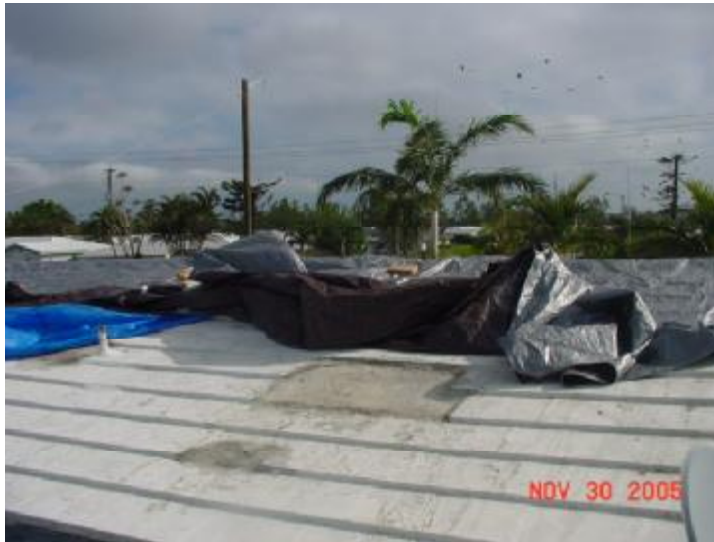
- 9      **ROOF DAMAGE**    11/30/2005  
1  
         rear slope connecting to flat roof

**ROOF:** 15.03 SQ OF CONCRETE FLAT TILES, DAMAGED WELL BEYOND 25%  
PATCHED BY INSURED, NO EXPENSE  
FLAT PART OF ROOF NOT DAMAGED.  
INSURED ROOF TARP RECIEPTS = \$76.20 +105.98= 182.18

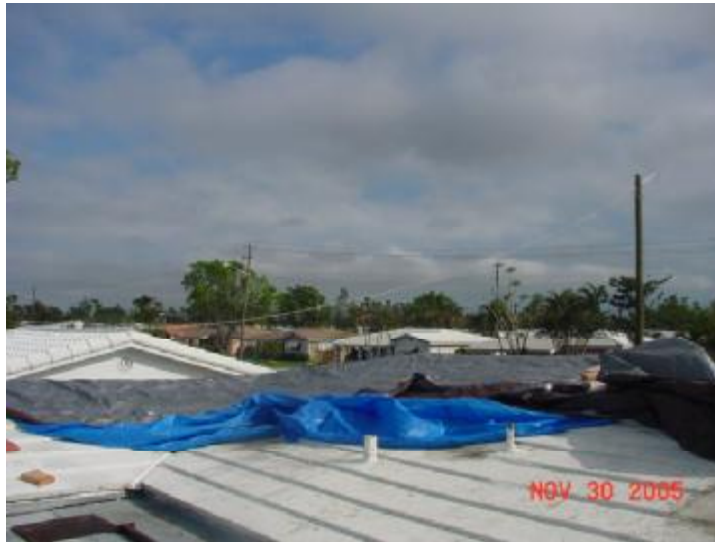
- 10    **ROOF DAMAGE**    11/30/2005  
2  
      **rear slope connecting to flat roof**

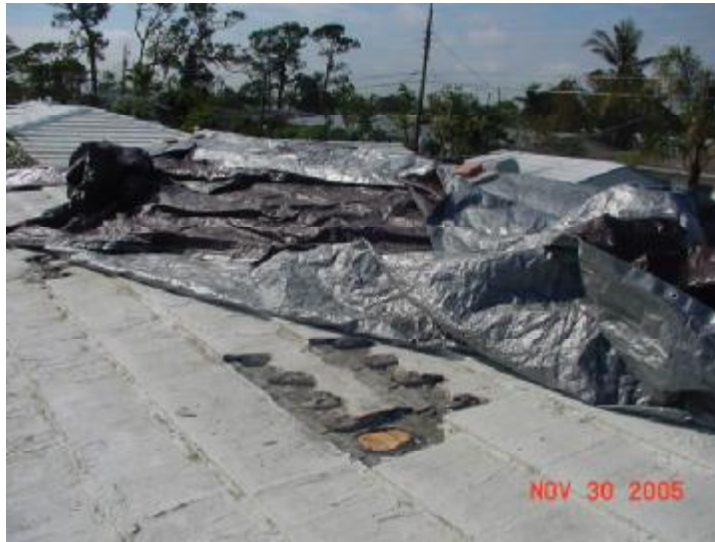
11    **ROOF DAMAGE**    11/30/2005  
3  
                                 front slope

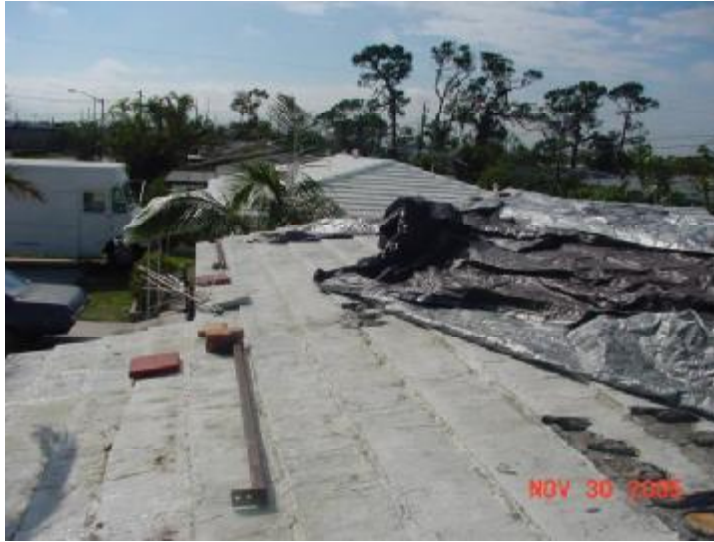
12 ROOF DAMAGE 11/30/2005  
4  
front slope

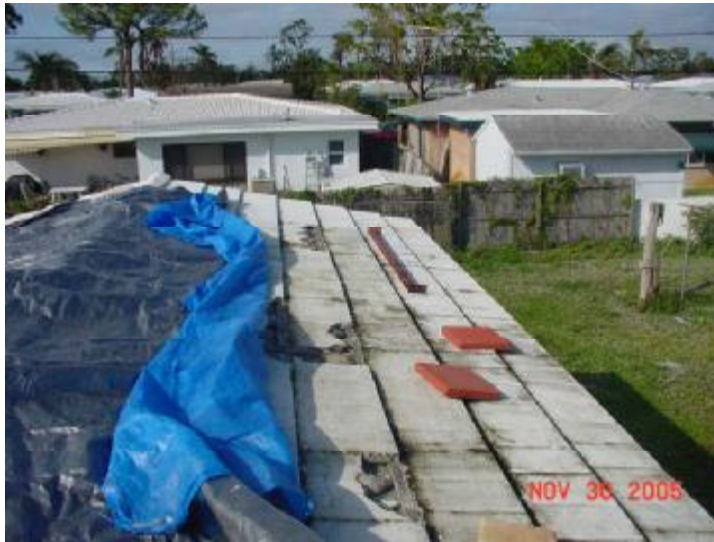
13 ROOF DAMAGE 11/30/2005  
5  
Rear slope

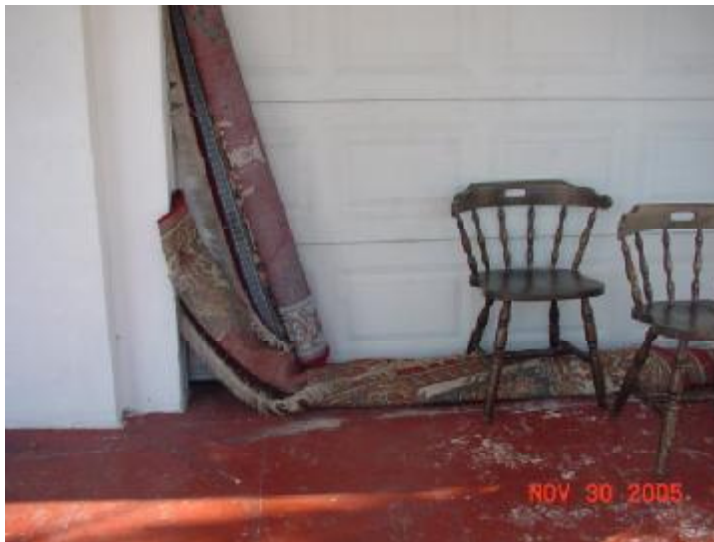
14 RUGS 11/30/2005  
water damaged placement rugs

CLEAN 2 DECOR PLACEMENT RUGS 10X 12 EACH
